## PROCESS INVESTIGATION REPORT EXAMPLE

Produced by MVC Solutions Ltd

Client : **MVC Solutions Ltd**  
Date of report : 11<sup>nd</sup> October 2020  
Report Version: : V0.2

In August 2020, MVC Solutions Ltd conducted a seven-day Flow and Load (F&L) study at the King's Bay Factory in East Surry. As a leading food manufacturing company with a range of confectionery products, the expansion of line 77 would allow recipes to be rotated cyclically every 24hrs to match demand.

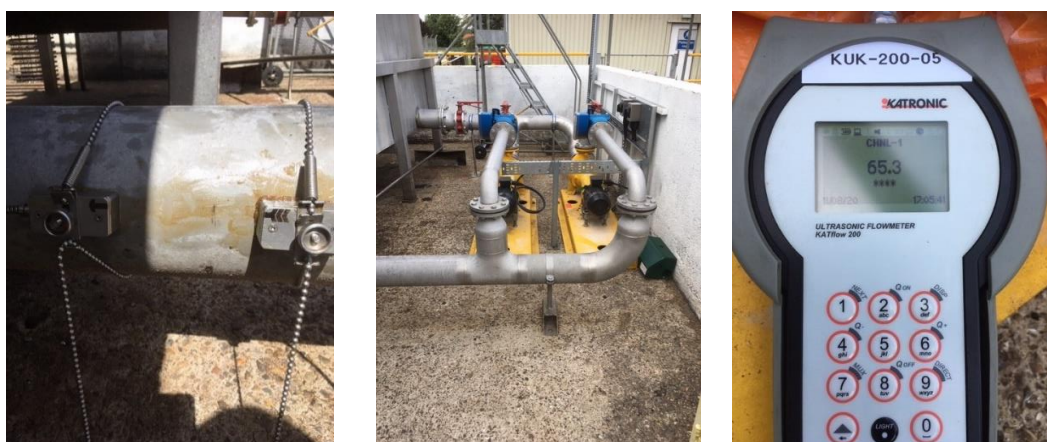
Above is an image of the Flow Logger recording an instantaneous flow reading of 65.3 m<sup>3</sup>/hr, which corresponded well with expected values based on the design pump curve. The average overall recorded flow during the F&L Study was 18.4 m<sup>3</sup>/hr or 442 m<sup>3</sup>/day, with a peak flow rate of 600 m<sup>3</sup>/day.

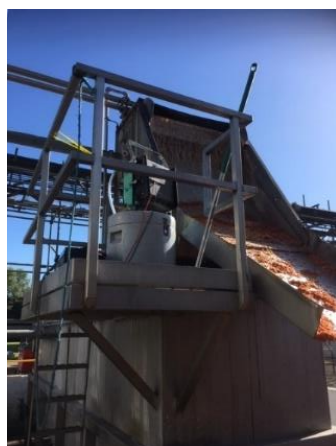
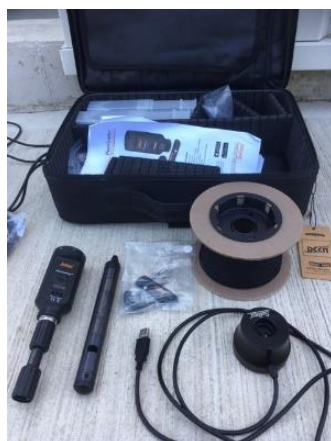
24hr Comp Autosampler      Temperature Monitor

The 24hr composite autosampler was located on the access platform adjacent to the 1mm Screen. A sample hose was positioned approximately 30cm from the bottom of the Holding Tank and secured to the handrail with cable ties. Access to the platform was restricted by black & yellow security tape to prevent any unauthorised personnel climbing onto the platform.

The composite carousel of the autosampler enabled 48 samples to be taken in 30-minute intervals to produce a 24hr composite sample. Collection of the 24hr composite sample was completed routinely every morning at 8am. Samples were sent daily to the Laboratory for Accredited Analysis.

The temperature probe was also positioned inside the Holding Tank at a depth approximately 30cm from the bottom of the Tank. Secured to the access platform handrail with black & yellow security tape prevented access to any unauthorised personnel, the probe recorded readings of both temperature and level every 2x minutes.

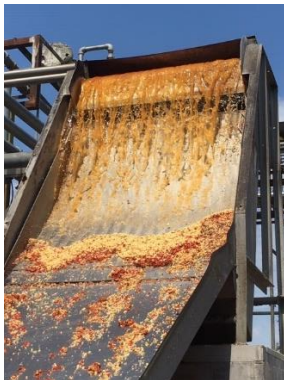
Inlet Screen

On Saturday afternoon 08.08.2020 at 14:15pm, an unusual RED effluent entered the Inlet Screen. The observed Spot sample is orange in colour with sediment forming at the bottom of the bottle.

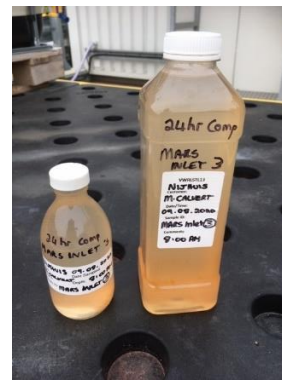
24hr Sample (tainted orange)

The unusual orange effluent was visible on the screen for approximately two hours and was sufficient to taint the 24hr composite sample.

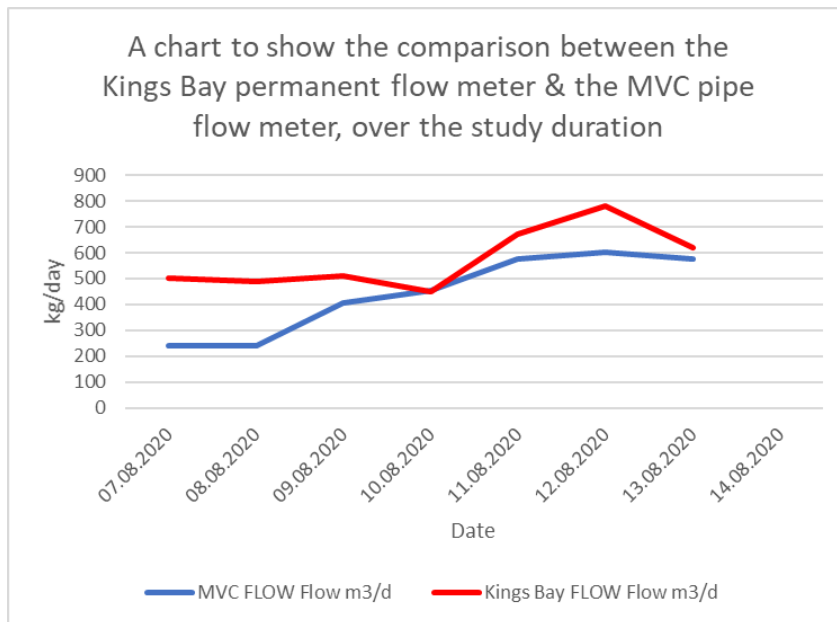
Chart 1.

Max, Min, and Average Effluent Flow readings during the study period in m3/day

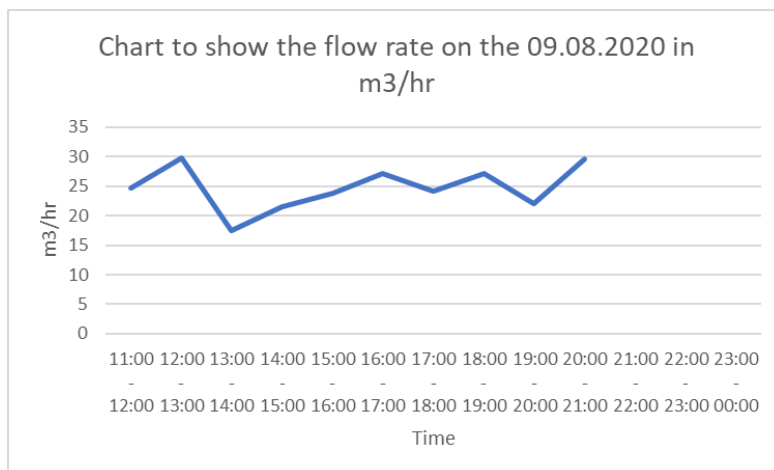
Chart 2.

Inlet effluent flow readings recorded during the study period in m3/day

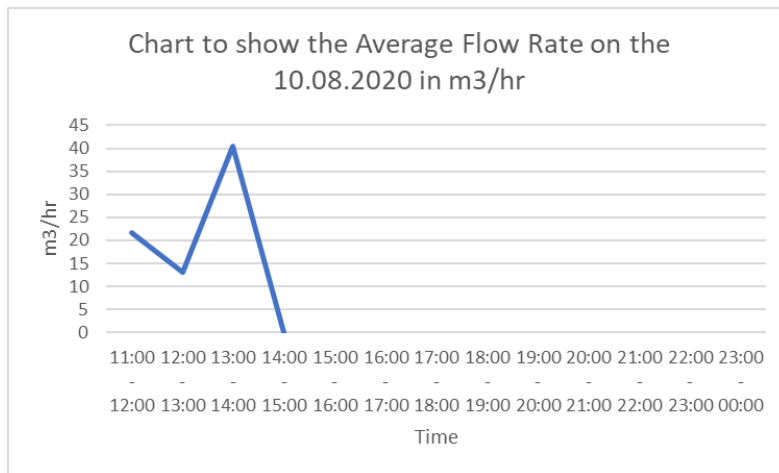
Chart 3.

Inlet effluent flow readings recorded during the study period in m3/day

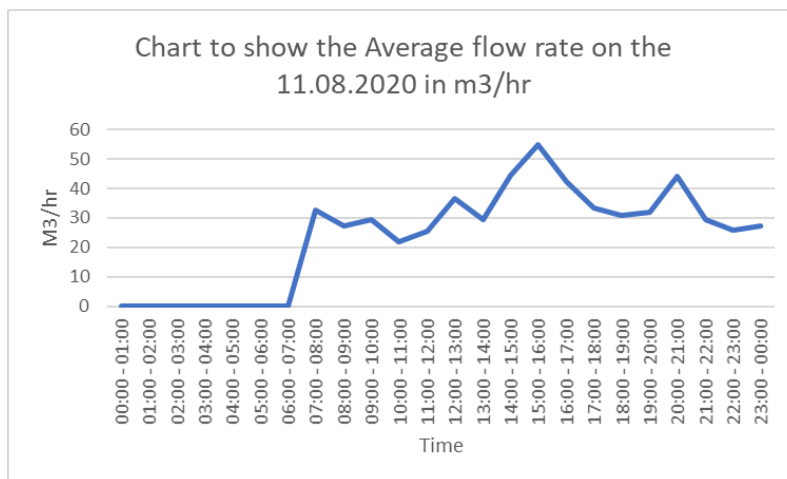
Chart 4.

Inlet effluent flow readings recorded during the study period in m<sup>3</sup>/day

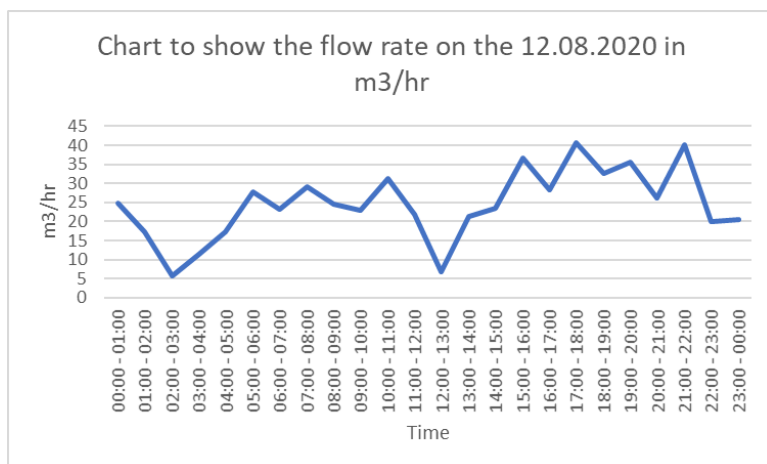
Chart 5.

Inlet effluent flow readings recorded during the study period in m<sup>3</sup>/day

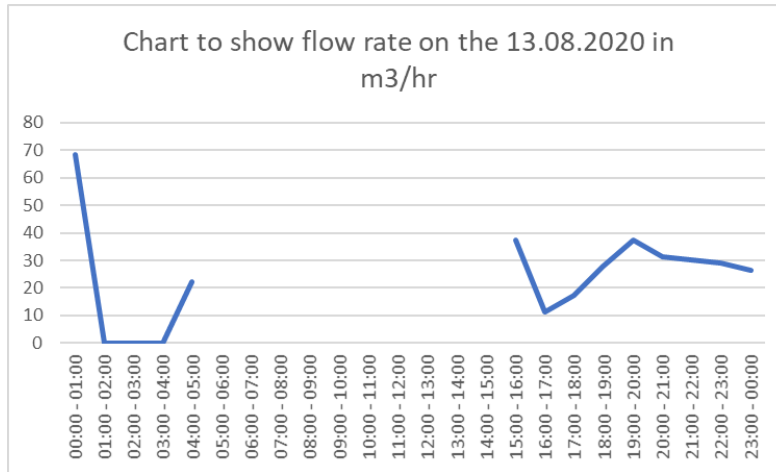
Chart 6.

Inlet effluent flow readings recorded during the study period in m<sup>3</sup>/day

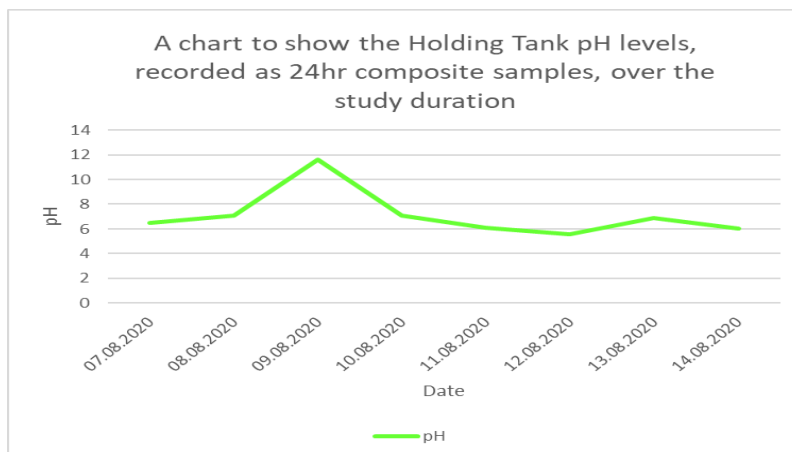
Chart 7.

Max, Min & Average pH levels during the study period (07.08.2020 - 14.08.2020)

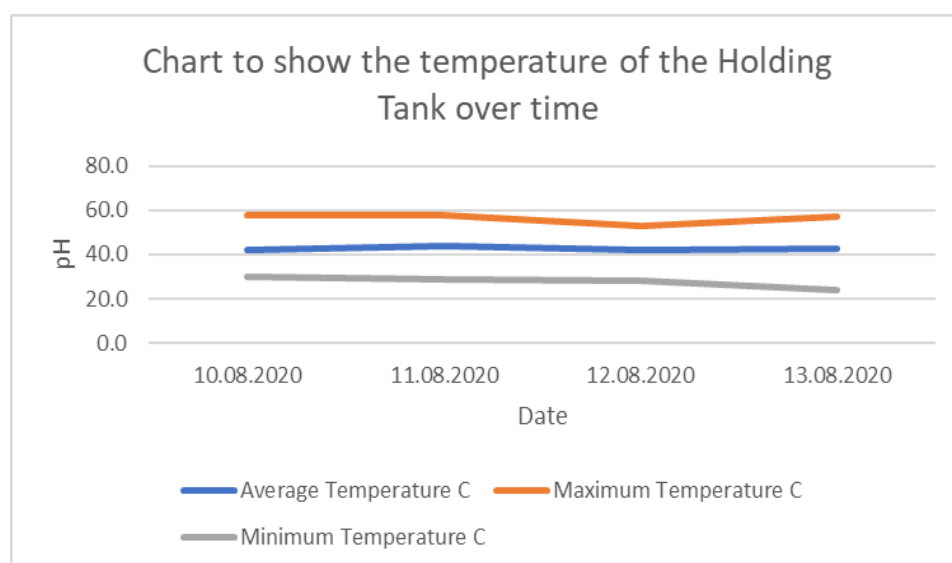
Chart 8.

Max, min & Average Temperature (C) readings over the study period (07.08.2020 to 14.08.2020)

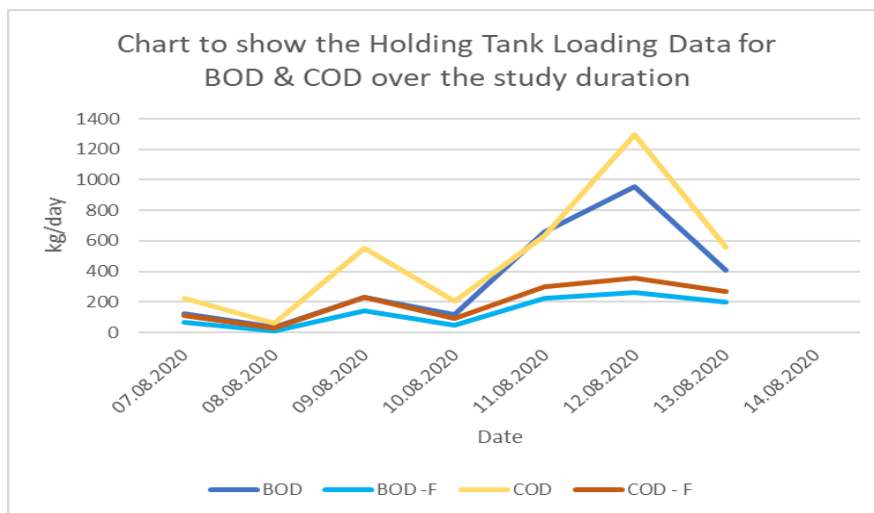
Chart 9.

Chart to show the Max, Min, Average BOD & COD loading rates in kg/day over the 24hr study period 07.08.2020 - 14.08.2020

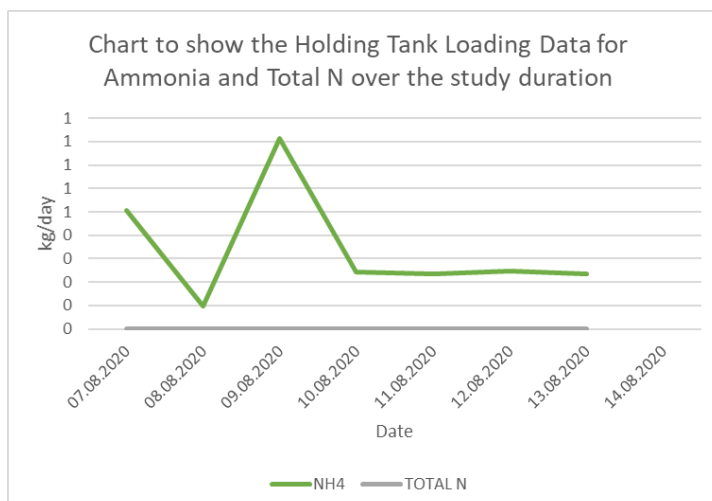
Chart 10.

Chart to show the Max, Min & Average Ammonia/Total N loading rates over the study period 07.08.2020 – 14.08.2020 and measured in kg/day

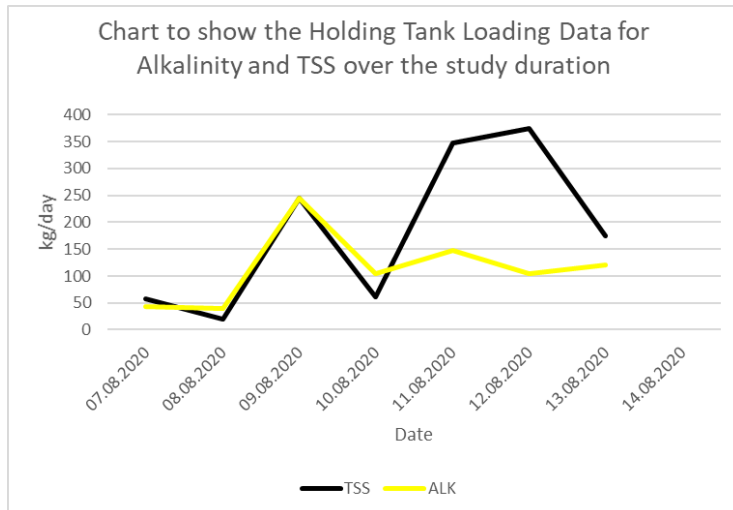
Chart 11.

Chart to show the Max, Min & Average TSS & Alkalinity loading rates over the study period 07.08.2020 - 14.08.2020 and measured in kg/day

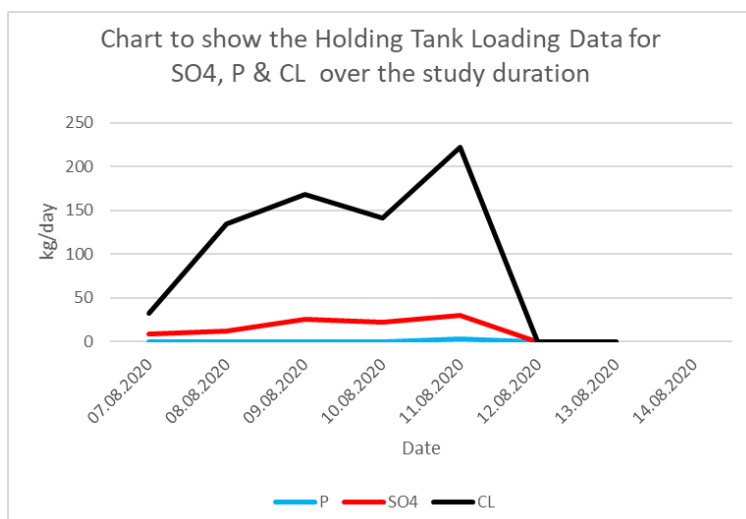
Chart 12.

Chart to show the Max, Min & Average Cl, SO4 and P loading rates over the study period 07.08.2020 - 14.08.2020 and measured in kg/day

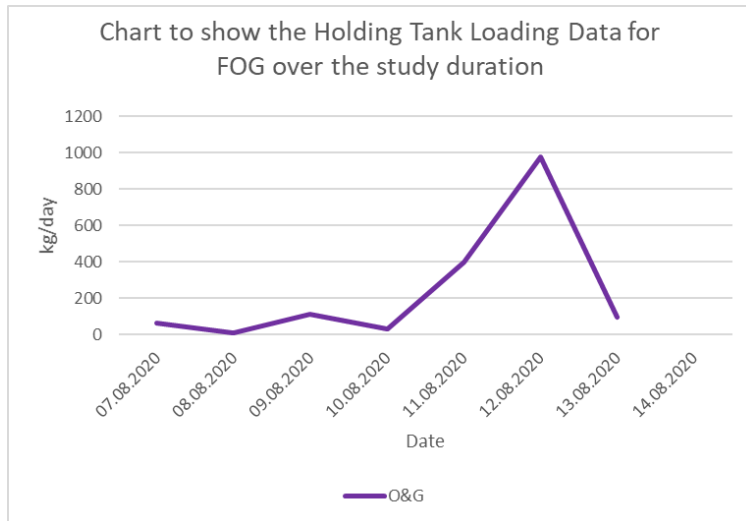
Chart 13.

Chart to show the Max, Min & Average FOG loading rates over the study period 07.08.2020 - 14.08.2020 and measured in kg/day

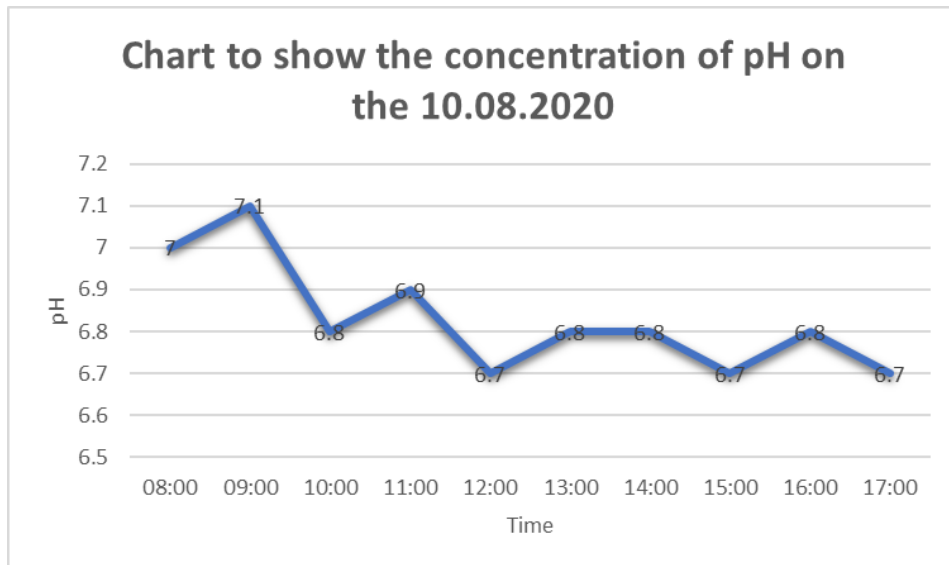
Chart 14

Chart to show the Max, Min & Average onsite SPOT pH reading taken over the study period 07.08.2020 – 14.08.2020

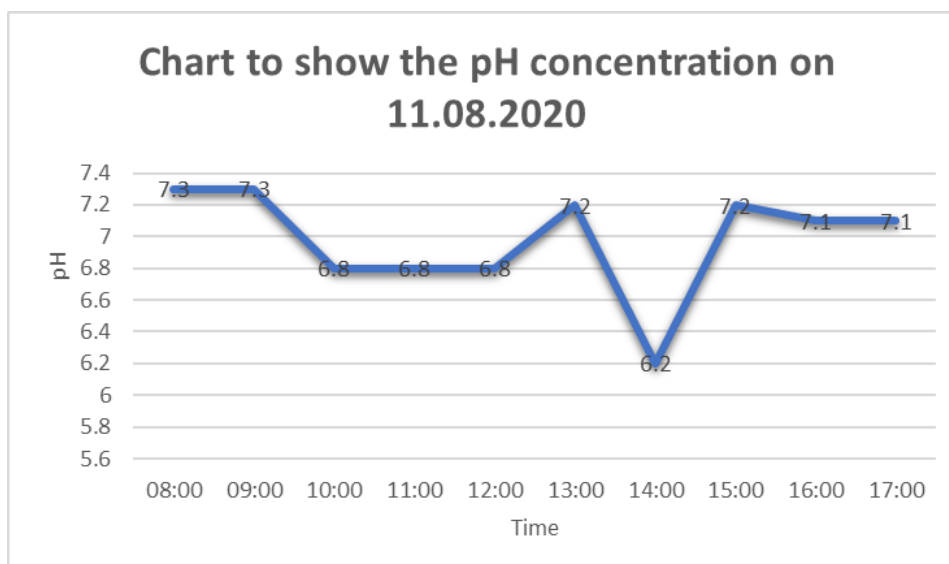
Chart 15

Chart to show the Max, Min & Average onsite SPOT pH reading taken over the study period 07.08.2020 – 14.08.2020

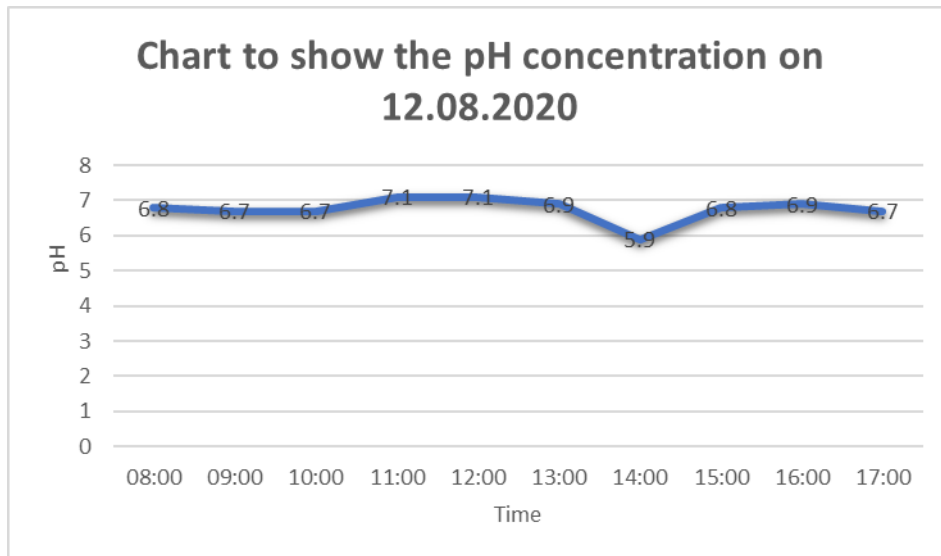
### Chart 16

Chart to show the Max, Min & Average onsite SPOT pH reading taken over the study period 07.08.2020 – 14.08.2020

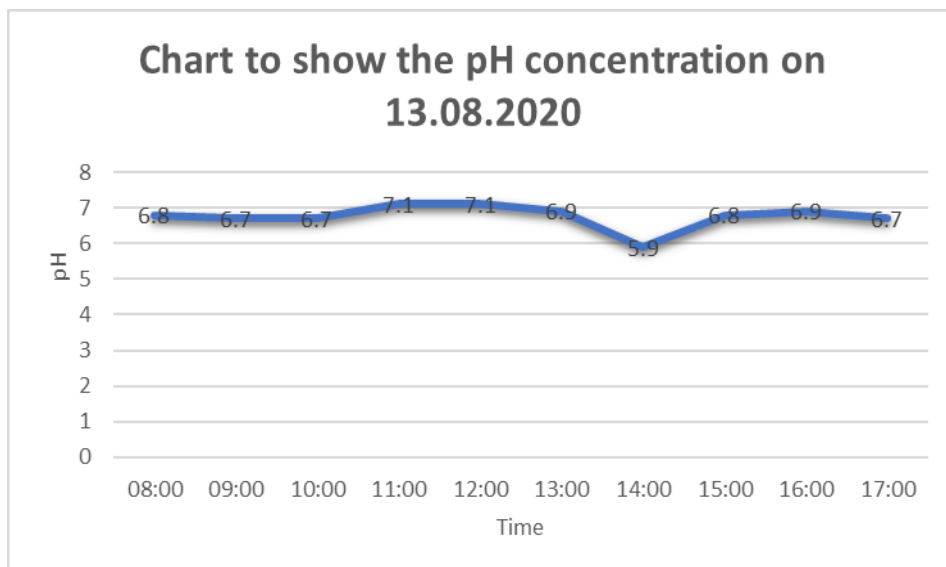
### Chart 17

Chart to show the Max, Min & Average onsite SPOT pH reading taken over the study period 07.08.2020 – 14.08.2020

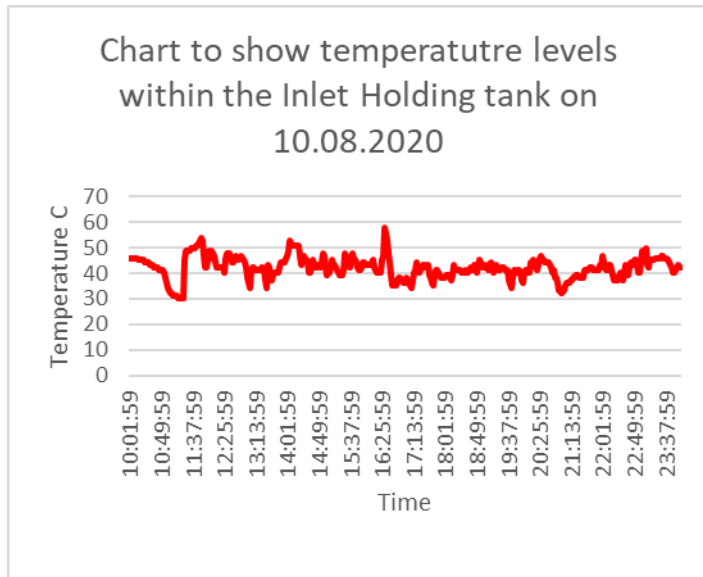
Chart 18

Chart to show the Holding Tank Temperature levels taken over the study period 07.08.2020 – 14.08.2020

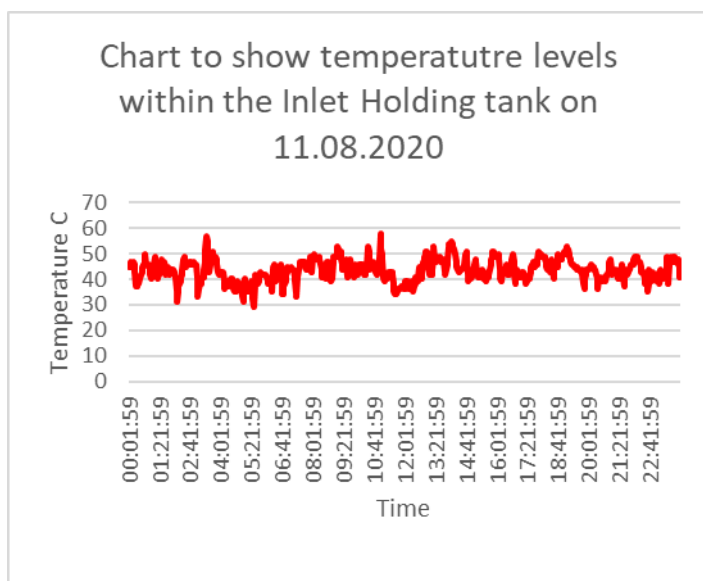
Chart 19

Chart to show the Holding Tank Temperature levels taken over the study period 07.08.2020 – 14.08.2020

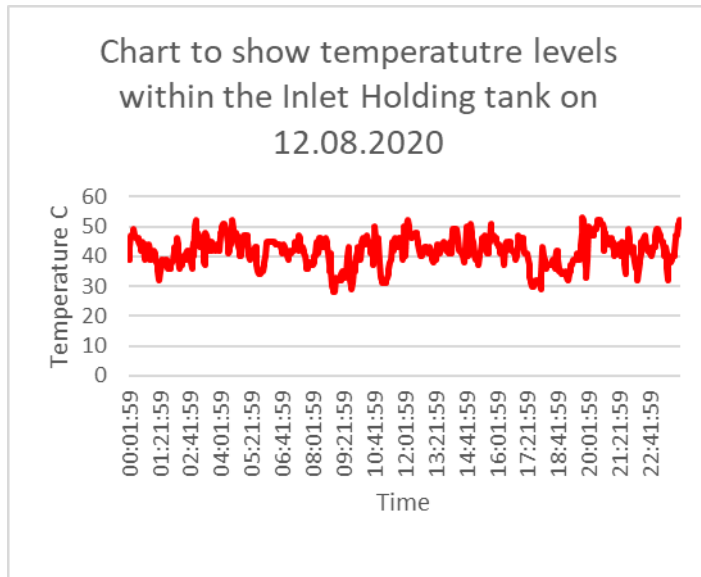
Chart 20

Chart to show the Holding Tank Temperature levels taken over the study period 07.08.2020 – 14.08.2020

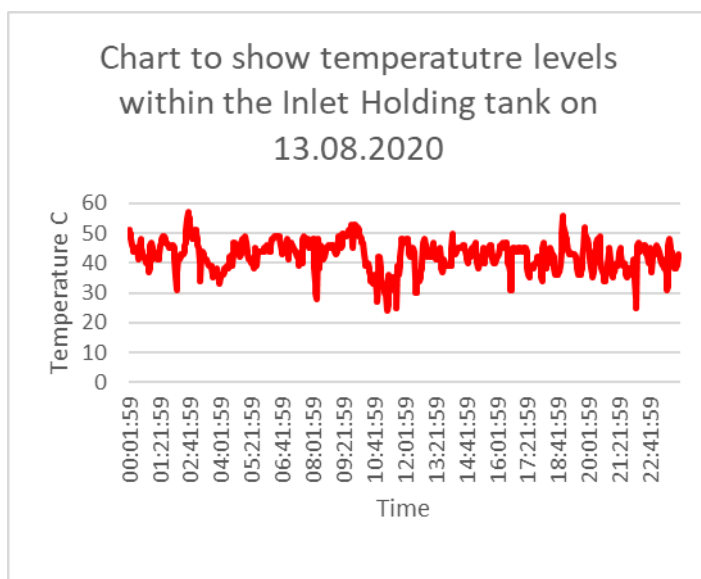
Chart 21

Chart to show the Holding Tank Temperature levels taken over the study period 07.08.2020 – 14.08.2020
